SERVICE BULLETIN

SERVICE BULLETIN		No.: MSB-99E11-503e	
		Date: 1999-07-15	
Subject: OMISSION OF INJECTION TIMING IDENTIFICATION MARK		<Model> ALL MODELS	<M/Y> 99-10
Group: ENGINE		Draft No.: 99EN511109	
CORRECTION	OVERSEAS SERVICE DEPT

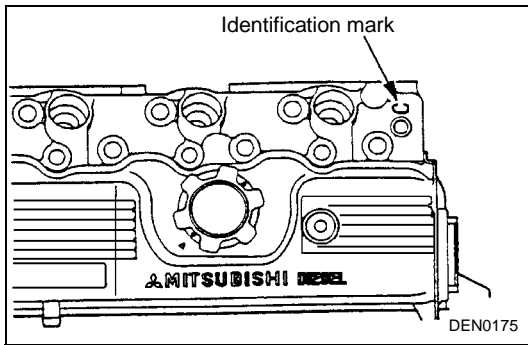
Omission of the injection timing identification mark has been rectified.

The injection timing can be known from the identification mark stamped on the cylinder head at the position shown in the illustration.

Identification mark	Injection timing
A or B	7° ATDC
C or D	9° ATDC

Or E <Added>
