# SERVICE BULLETIN

<b>SERVICE BULLETIN</b>		No.: MSB-98E11-501e	
		Date: 1999-05-15	<b>&lt;Model&gt;</b> (EC.EXP)PAJERO (V10,V20,V30,V40)
<b>Subject:</b> CORRECTION TO PISTON CLEARANCE		<b>&lt;M/Y&gt;</b> 98-10	
<b>Group:</b> ENGINE	<b>Draft No.:</b> 98EN570911		
<b>CORRECTION</b>	OVERSEAS SERVICE DEPT

Correction has been made to the piston clearance described in the following Workshop Manual.

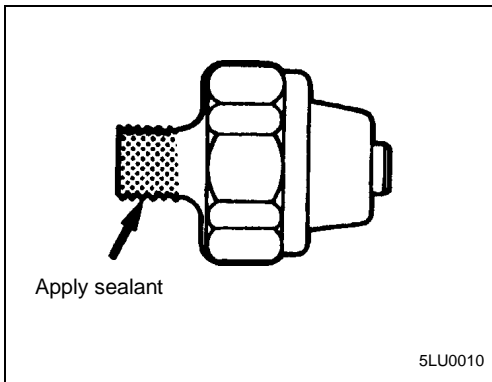
### APPLICATION OF SEALANT TO OIL PRESSURE SWITCH

- (1) Coat the threads of switch with sealant and install the switch using the special tool.

**Specified sealant:**

**3M ATD Part No. 8660 or equivalent**

**Caution**

- Keep the end of threaded portion clear of sealant.
- Avoid an overtightening.
